COLEMAN A. YOUNG MUNICIPAL CENTER

Americans with Disabilities Act Accessibility Compliance Review Report

Detroit-Wayne Joint
Building Authority

Project No. 1942.7050.00

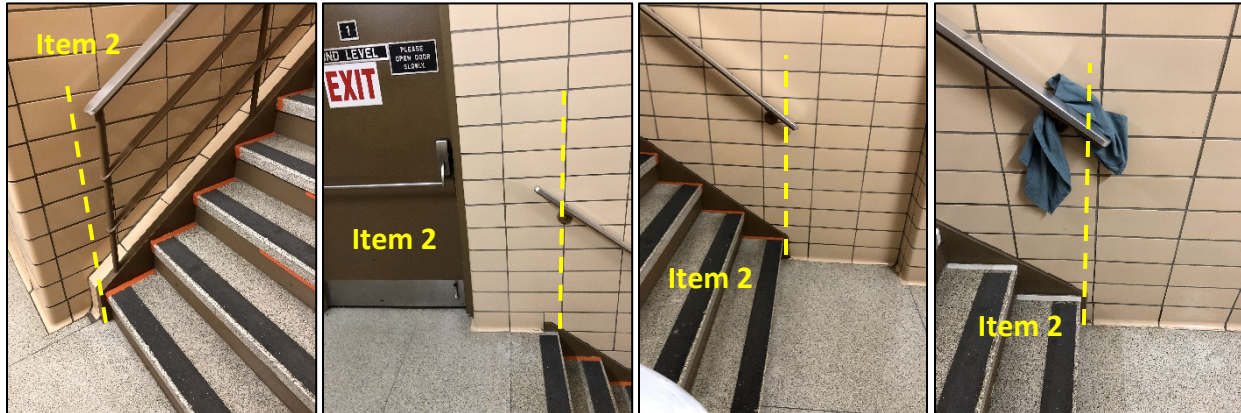
2. None of the five (5) stairwells have compliant handrails. Handrails lack the required extensions at the top and bottom and the height above the stair nosing to the gripping surface is below 34-38" required. This is not required to be corrected until the stairs are altered.

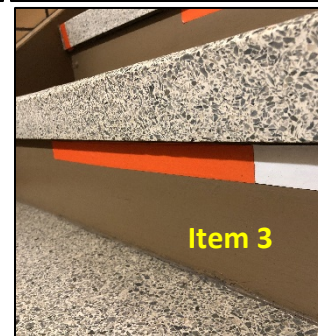
3. The stair nosings in all five (5) stairwells extend over the riser at a 90 degree angle, which creates a potential for a user's foot to catch and cause them to lose their balance. ADA standards require 30 degree maximum angle. This is not required to be corrected until the stairs are altered but is a safety item to consider.
4. Signage within the pre-security area informing the public that the accessible restrooms are available only in the lower level is of varied quality and desired location.

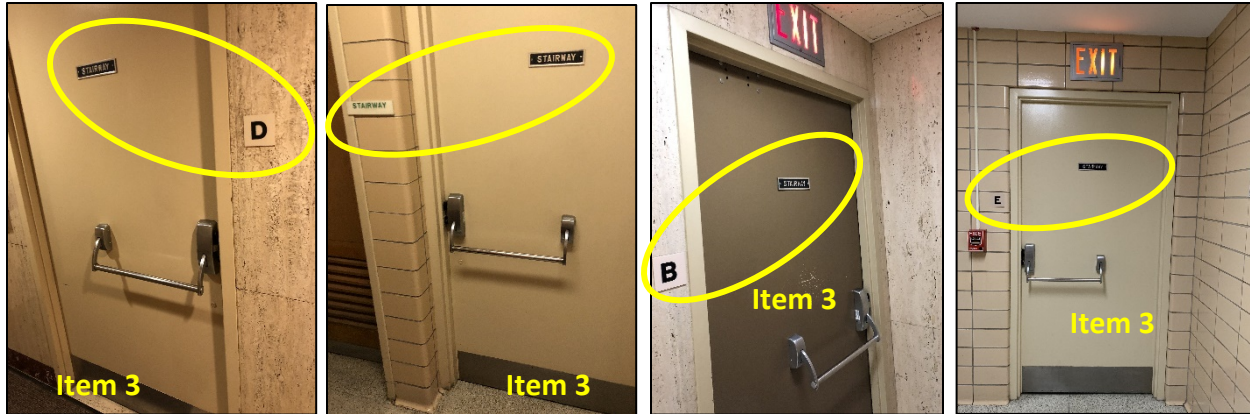
4. Panic bars on nearly all stairwell access doors protrude into the doorway opening 4-1/2" to 5" (4" max. allowed).
5. Access at all three (3) stairwells is limited on Level 1 due to doors being locked, and the existing hardware within the stairwells is non-compliant throughout (except Level 1), requiring depressing a button with the thumb and grabbing and pulling the handle with the remaining fingers. Hardware should be operable with a single, closed fist.

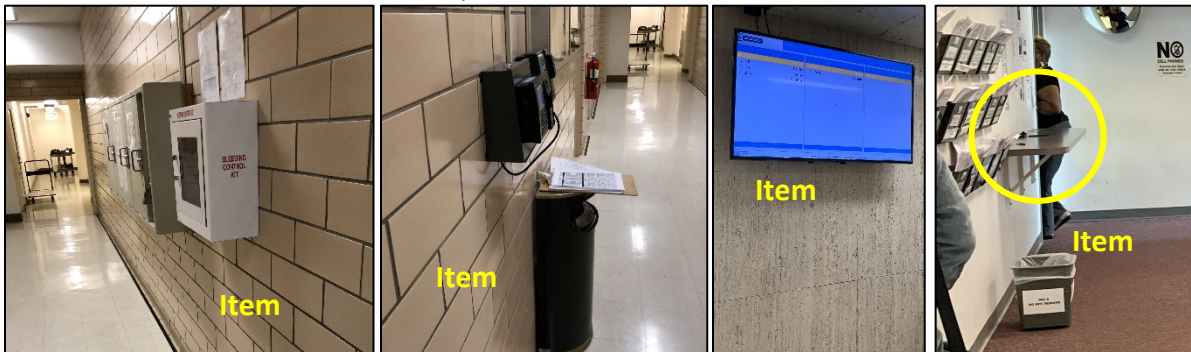
21. In addition to the common protruding objects above, there are unique protruding objects in the Office Tower at the following locations:
- The corridor at LL-06 has a bleeding control kit, lock boxes, and time clock that are protruding objects (typically 5-7" protrusion between 39" and 47").
 - At Room 408 there is a television monitor on the wall that protrudes 5-1/2" at 58-1/2".
 - Counter at corridor in Room 900A protrudes 16-1/4" at 38".

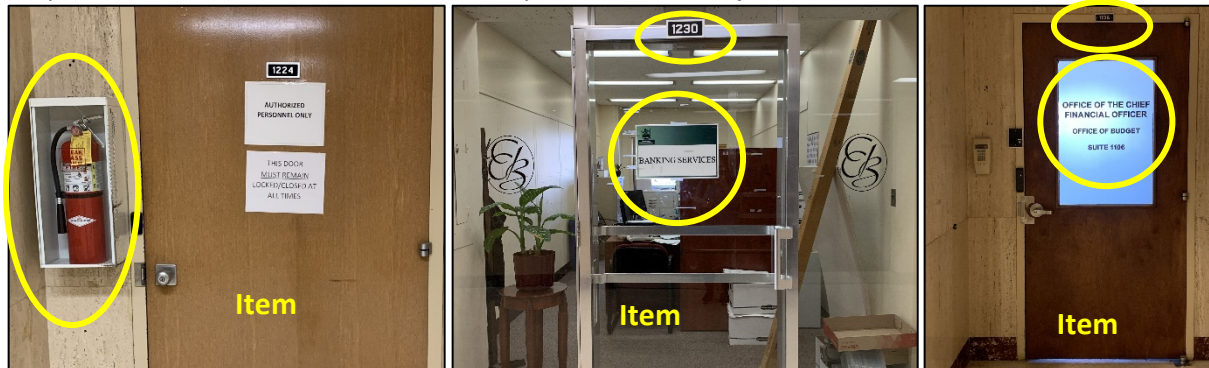
22. The maneuvering clear space on the pull side of access doors to Stair C and D is less than the minimum 18" required at the Lower Level.
23. Signage throughout the Office Tower at permanent spaces is often missing, in the wrong location, and/or does not include all required information. The required clear space at the signs on the latch pull side is also sometimes obstructed by FECs or other objects.

Examples of common signage issues (from left to right – non-compliant signage and obstructed clear space where sign should be located, door with paper visual sign and room number above the door, and visual signage etched/attached to glass with room number above the door (Item 23). Compliant signage would include visual and tactile letters with Braille located on the latch side wall adjacent to the door with an 18"x18" clear space at the sign outside of the door swing. Signs can be placed on the door only on the push side of the door. Many doors have no signage identifying the space beyond, with or without a room number sign above the door (Item 23).

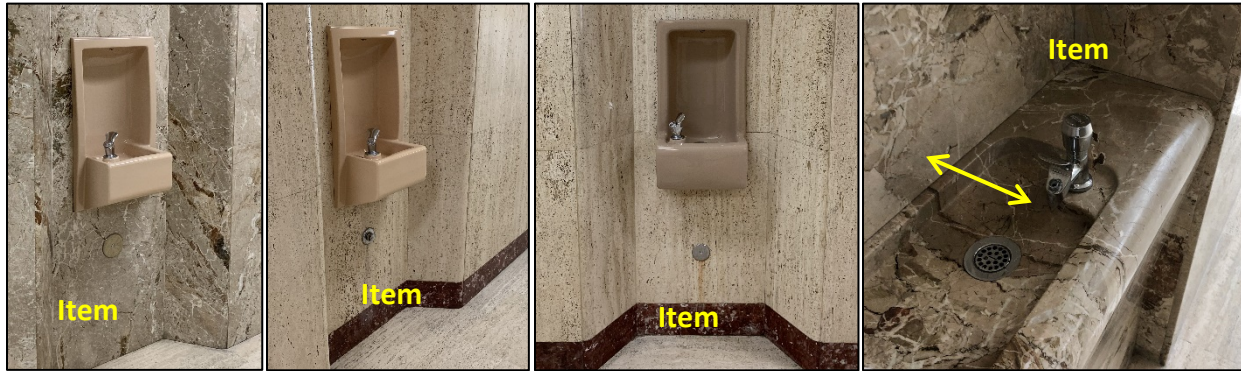
fountain alcove is too shallow and it is a protruding object where provided (LL and Levels 2-11 and 13-14).

Examples of drinking fountains original to the building. Most have compliant height bubbler for standing user compliance (38-43") though some are less than 38" high. The biggest compliance issues with these fountains is the shallow depth from the rear wall to the bubbler (15" min. required). This shallow depth makes it difficult to use and can be a hazard due to users hitting their head on the back wall (Item 24).

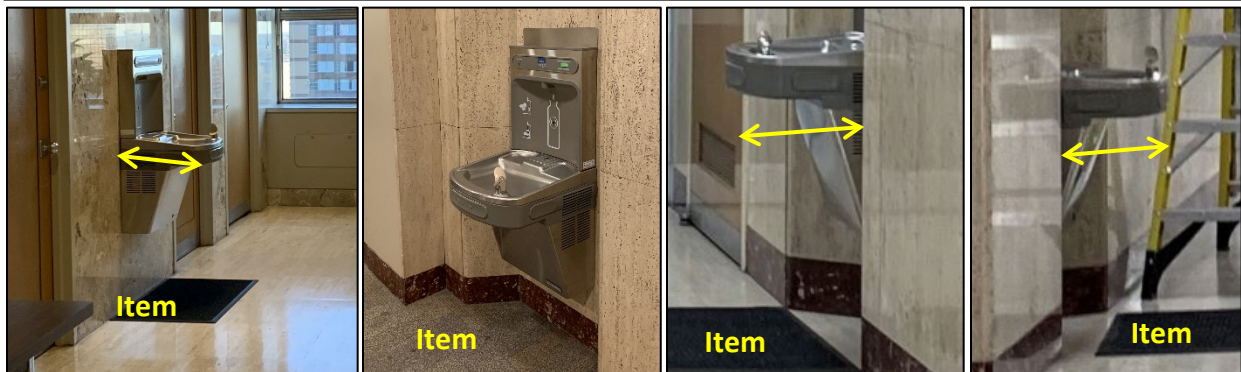
Examples of wheelchair user drinking fountains with bottle fillers that have been recently installed. Most have compliant height bubbler for wheelchair user compliance (36" max.) but some were installed with less than 27" knee space below and need to be reinstalled. The biggest compliance issues with these fountains is that they all protrude into the pedestrian circulation area since they were installed in original alcoves that are too shallow (Item 24).

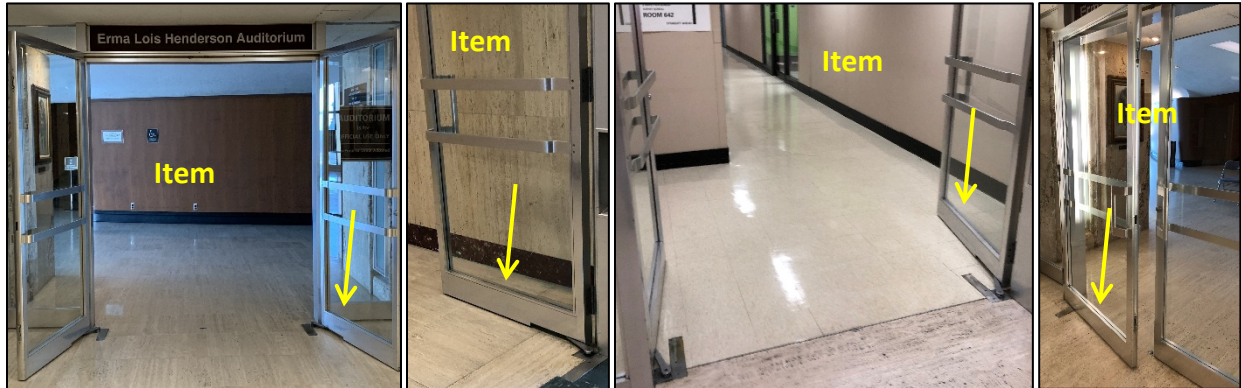
32. The corridor access to the Skywalk accessible door on Level 2 is only 44" wide (48" min. req'd. for latch side approach to a door with a closer). The door also lacks prominent signage as the accessible route.
33. Main hallway double doors at public corridors connecting the Office Tower and Court Tower are typically locked in the open position. Doors have glass typically located only 6" above the floor on the push side (10" min. required) on Levels 3, 6 (3 sets), and 13. These doors could have the glass broken by a wheelchair footrest.

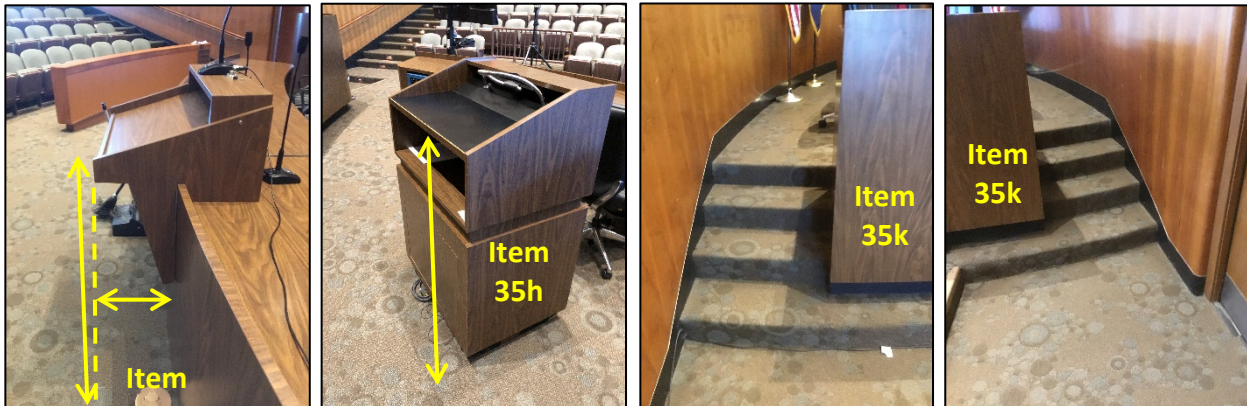
- k. The only access to the commissioner's upper level is via a set of steps on either end. The steps lack handrails on both sides as required and there is no access to persons in a wheelchair to this level. The width of the access may be an issue when altered, depending on the corrective action implemented (36" min. width required). Clear space on the upper level is somewhat limited for circulation but adequate if wheelchair space provided on one end.

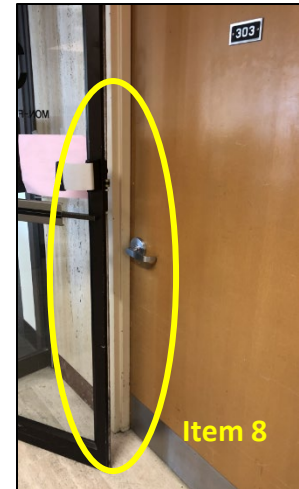
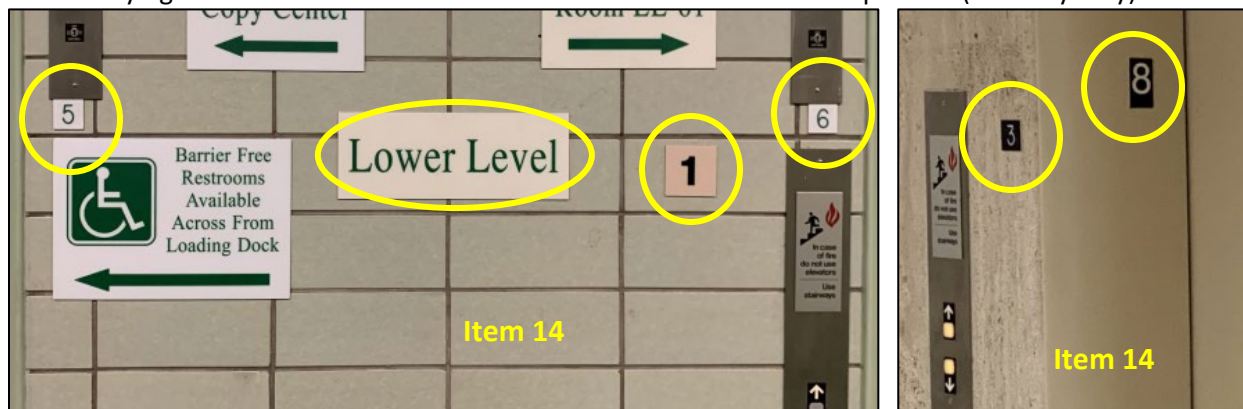
14. The numbering of the elevators that is provided in the lobby could be potentially confusing to some members of the public, as the Elevator # and floor numbers are often in close proximity. Consider modifying the location of the elevator number labels to be less conspicuous (advisory only).

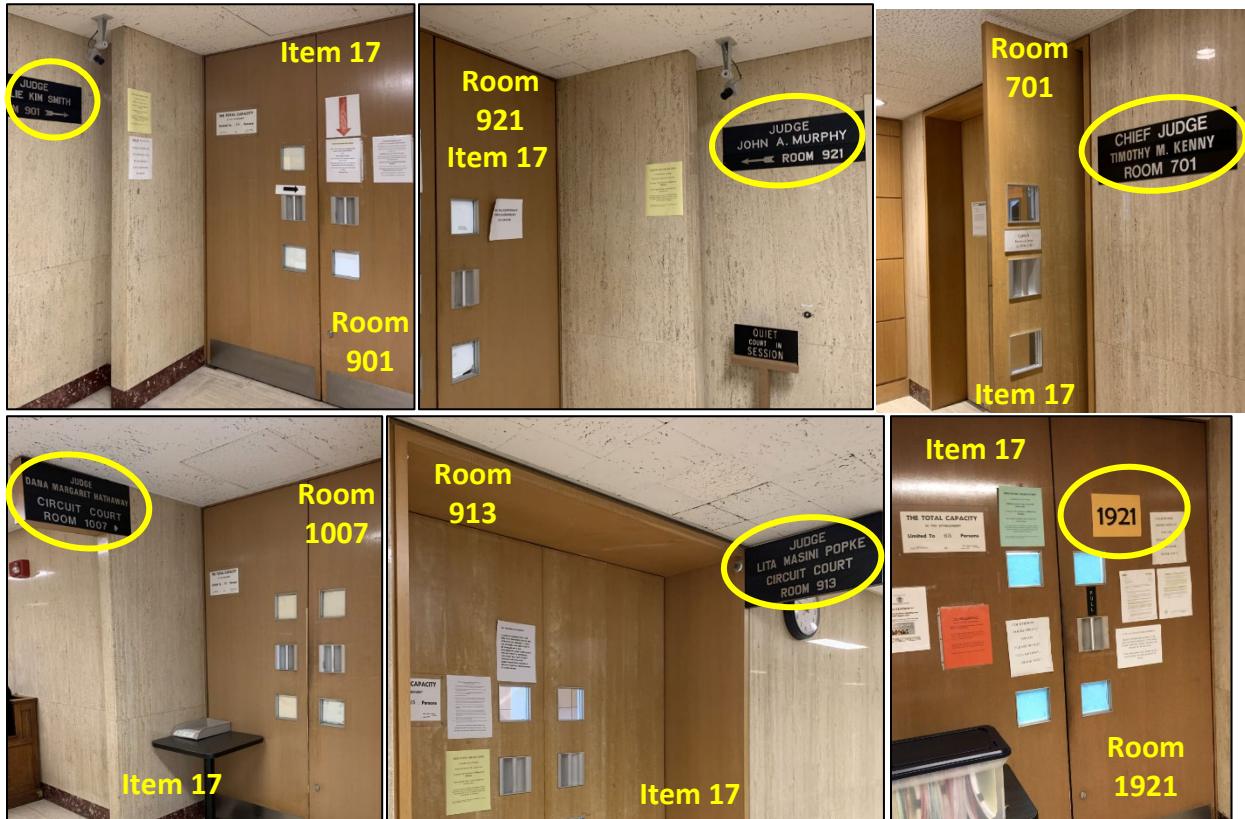
Examples of various non-compliant signage at courtrooms in the Court Tower (Item 17). Visual text signage is circled where it is present. Note the amount of visual text signage on many courtroom doors.

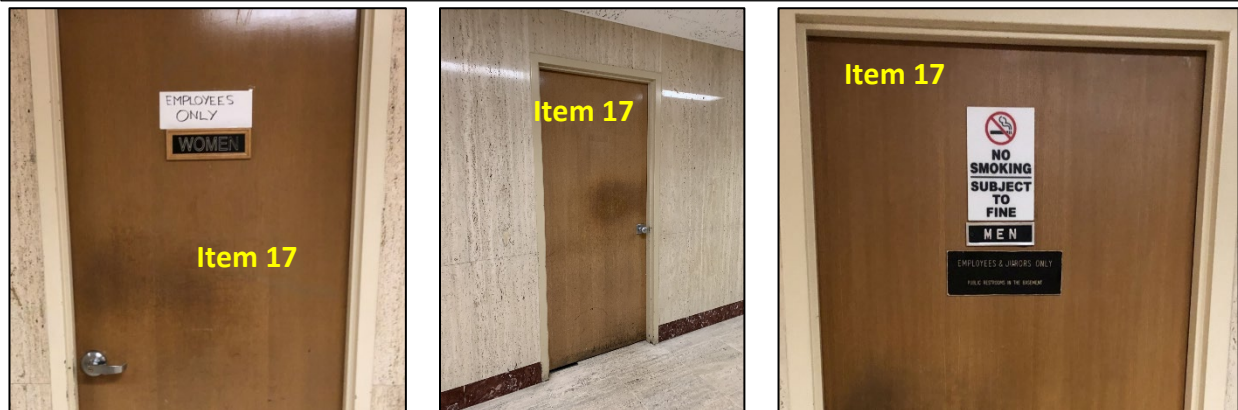
Examples of public and/or employee-only restroom with non-compliant or missing signage (Item 17).

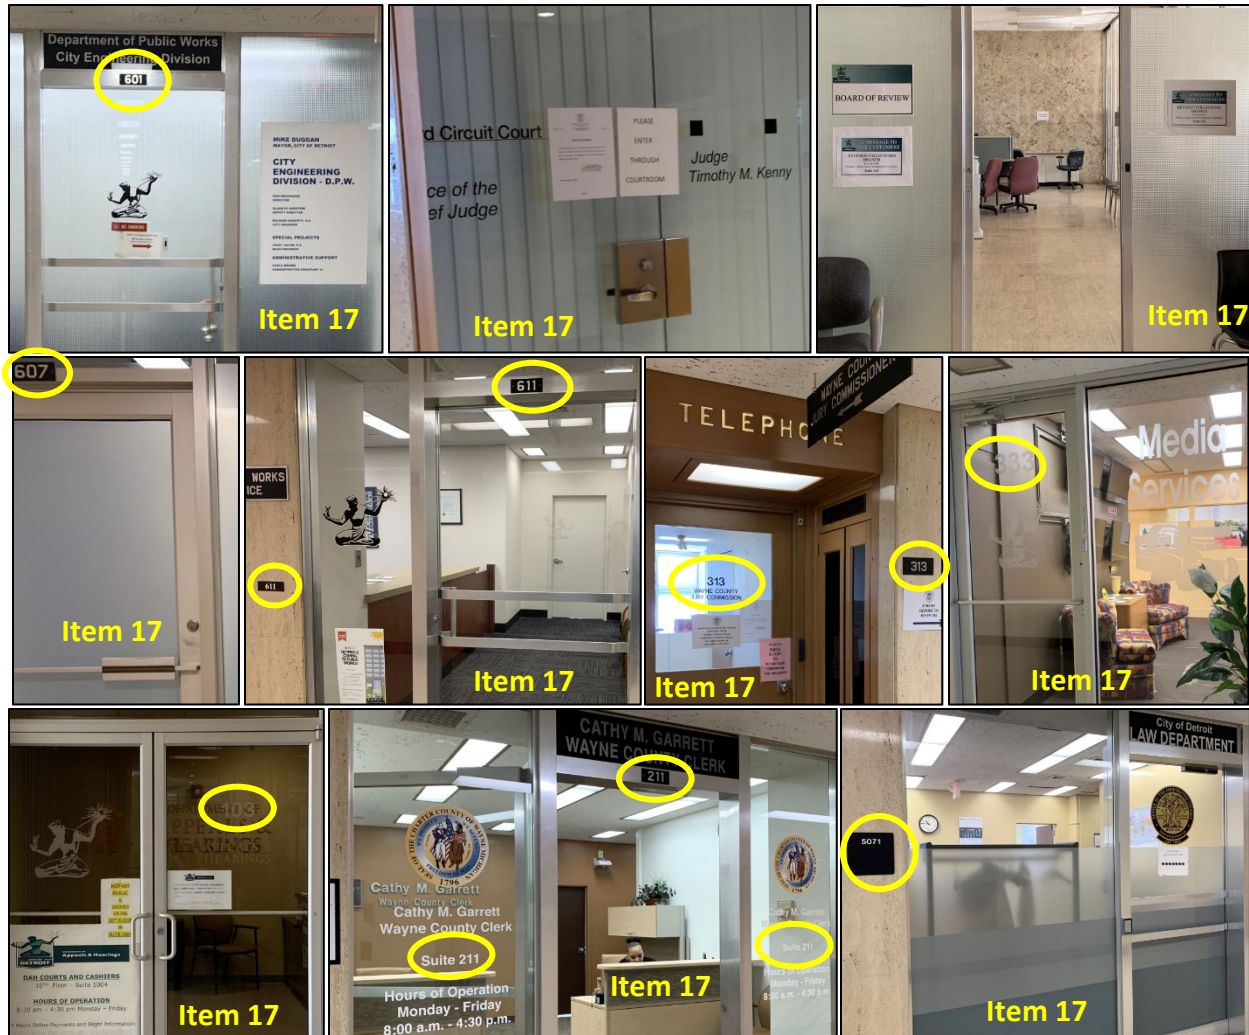
Examples of City and County offices with non-compliant signage, often it is visual text only with a room number sign above the door or as part of the other text on the wall/door. Some rooms have compliant signage located too far from the door. Room number is circled where it is present (Item 17).

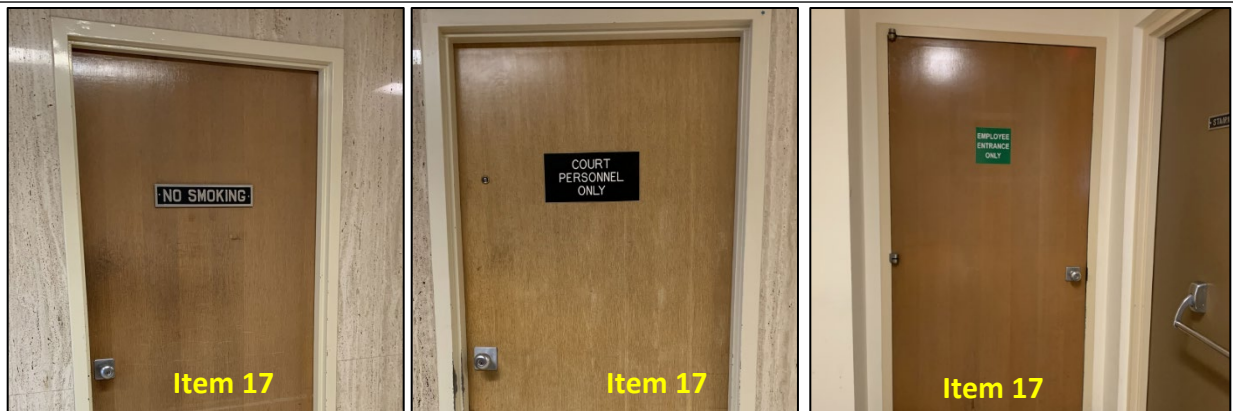
Examples of non-compliant visual text only signage provided on doors (Item 17).

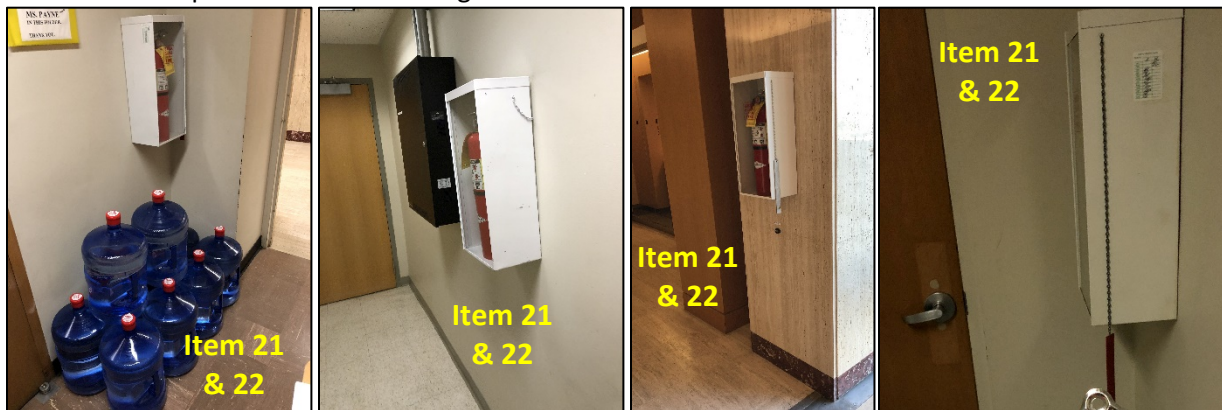
19. Doors to access both (2) stairwells on all levels require excessive force to open (>5 lbs. of force) and/or close too quickly and adjusting the closers should be attempted to correct deficiencies.
20. Light switches located within public corridors, where provided, at typically above 48" high maximum required by 2010 ADA Standards. All switches found did meet the 54" maximum permitted by the 1991 standards.
21. Fire extinguisher cabinets (FEC) located throughout the Court Tower often are protruding objects. In some stairway foyers, there are non-permanent obstructions at FECs that are cane-detectable.
22. Many FECs are mounted at a height that would put the glass-breakage hammer (if placed on top of the cabinet as was observed in some locations) and handle of the extinguisher above 48". If moved, ensure compliant location and height.

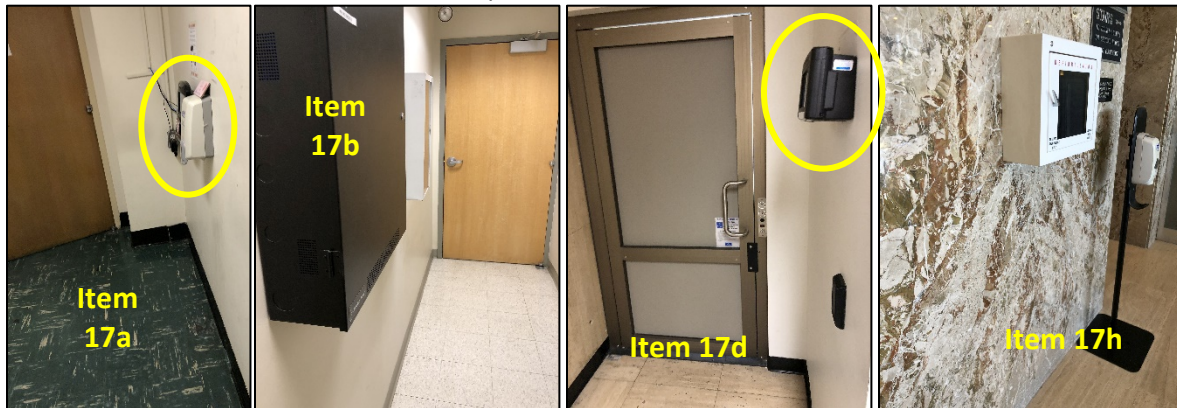
- a. At Stair B lobby on Level 2 there is a hand sanitizer dispenser on the wall that protrudes 5" at 39-1/2".
- b. Fire alarm controls at Stair B on Levels 3, 6, 15, protrudes 4-1/4" at 55-1/2" to 56-1/4".
- c. Fire alarm control box at Stair B on Level 5, 8 protrudes 7" at 44" to 45-1/2".
- d. Card reader at the wheelchair lift alcove near Room 1307 protrudes more than 4".
- e. Fire warden box at Stair B on Level 14 protrudes 5-1/2" at 45".
- f. Countertop height at payment window at Room 1907 is 41" high (36" max.).
- g. Hand sanitizer dispenser at Stair B protrudes 5" at 39-1/2".
- h. AED near the Court Tower elevators protrudes 6" at 51".

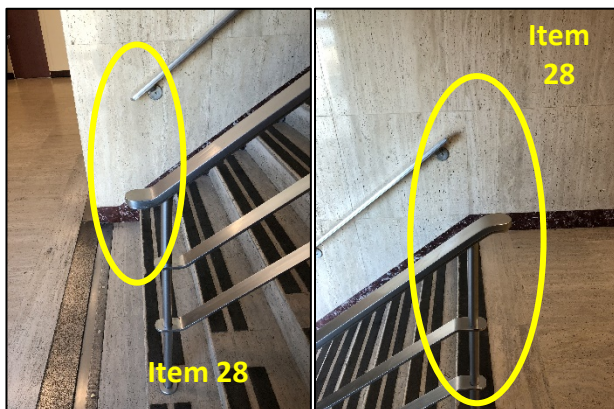
- a. Handrail extensions at the top and bottom are less than 12" min. at the top parallel to the ground and 1 tread depth at the bottom (11" min.).
- b. Handrails are mounted at 31-1/2" to 33" high (34-38" req'd.).
- c. Stair nosings extend over the riser at a 90 degree angle, which creates a potential for a user's foot to catch and cause them to lose their balance. ADA standards

require 30 degree maximum angle. This is not required to be corrected until the stairs are altered but is a safety item to consider.

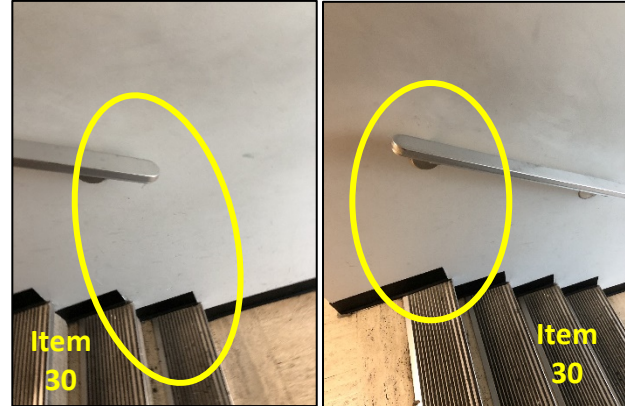
- a. Handrail extensions at the top and bottom are less than 12" min. at the top parallel to the ground and 1 tread depth at the bottom (11" min.).
- b. Handrails are mounted at 31-1/2" to 33" high (34-38" req'd.).
- c. Stair nosings extend over the riser at a 90 degree angle, which creates a potential for a user's foot to catch and cause them

to lose their balance. ADA standards require 30 degree maximum angle. This is not required to be corrected until the stairs are altered but is a safety item to consider.
